Systems and Concepts for Repair and Strengthening

Systems and Concepts for Repair and Strengthening of Bridges and other Structures

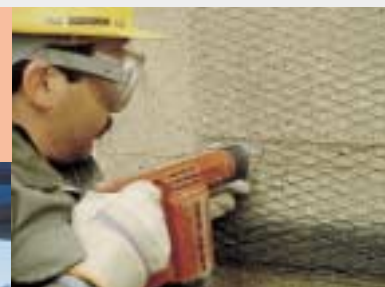
Outer Noesslach Bridge, Brenner Highway, Austria

The concrete of the 50 m high piers at the buttresses of the 180 m long arches was highly chloride contaminated up to a depth of 60 mm due to twenty years of exposure to de-icing salts. CP was applied to 1,500 m² of the concrete surface, as only this measure did not jeopardize the load-bearing capacity and stability of the bridge. Efficiency and performance of the CP system can be monitored at any time through potential measurements.

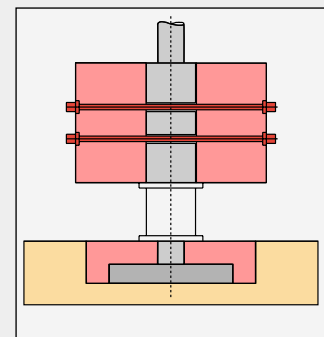
MRT rapid transportation network, Muza Line, Taipei, Taiwan

In 1994 cracks were discovered in the concrete corbelled pier caps of the Muza line steel girder viaduct. The emergency repair scheme consisted of placing external $\varnothing 36$ mm DYWIDAG bar tendons (THREADBAR®) on both sides of the pier cap. These were anchored in steel grillages at each end of the caps and were supplied with DYWIDAG double corrosion protection system. All exposed steel parts of the grillages were protected by a three coat paint system. On selected tendons permanent load cells were installed to monitor the prestressing forces.

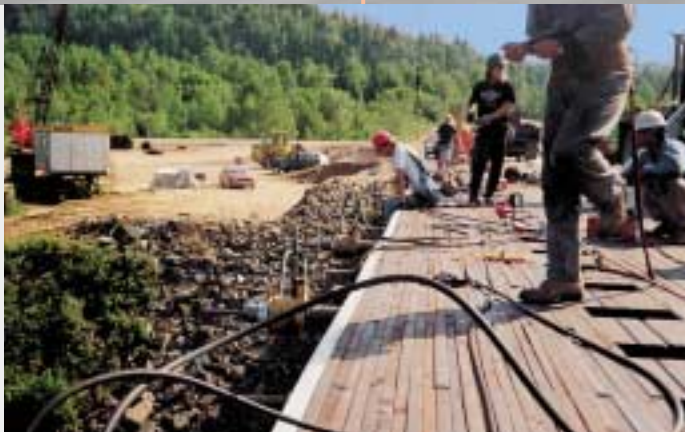
Cripple Creek Bridge, Highway 101, Ontario, Canada

The existing transverse nail-laminated timber deck was replaced with a longitudinally laminated, transversely prestressed timber deck. The bridge was repaired in two stages to maintain one traffic lane at all times.

The transverse prestressing system consists of galvanized \varnothing 26 mm DYWIDAG bars (THREADBAR®) placed at 300 mm spacing. Tensioning was repeated 1 week and 5 weeks after the initial stressing operation, to compensate for the large creep losses in the timber deck system. DYWIDAG bars (THREADBAR®) easily allow the repeated retensioning both at the time of construction, and in the future if necessary. Connecting of the tendons between the 1st and 2nd stage construction was accomplished by using standard couplers.

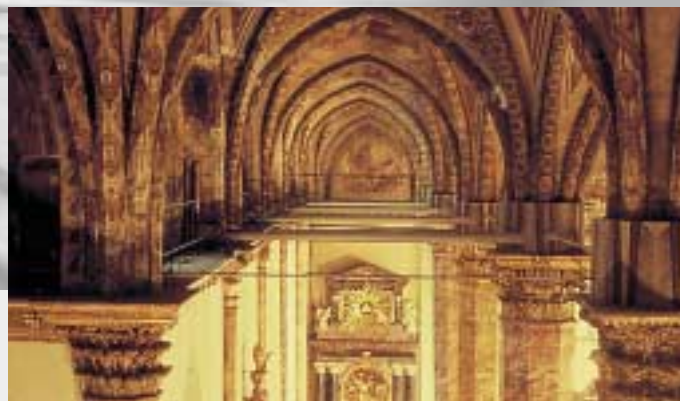
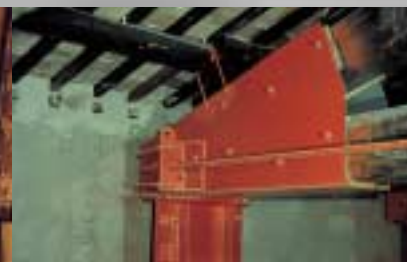
San Lorenzo Cathedral, Perugia, Italy

The San Lorenzo Cathedral was built between the 14th and 15th centuries. Already in 1633-1641 important consolidation works had been carried out, since, because of the weight of the roof, the columns and the walls had diverged. Seismic movements in 1983 caused further damage, thus endangering the stability of the monument. A new consolidation and restoration project was decided after a thorough historical survey of the original and subsequent static behavior of the structure. The twenty-three timber roof trusses were reinforced by strengthening the joints with steel plates and bolts and by prestressing both

the lower tie beam and the central king post with two twin $\varnothing 36$ mm DYWIDAG bars (THREADBAR®) each. The column capitals showed displacements of up to 26 cm. A new system of transverse and longitudinal ties made of DYWIDAG bars (THREADBAR®) was introduced into the columns and walls to prevent any side displacements. The transverse tie members were prestressed and tied back to the lateral walls in order to apply to the whole structure a system of acting forces capable of counteracting the thrusts of the vaults.

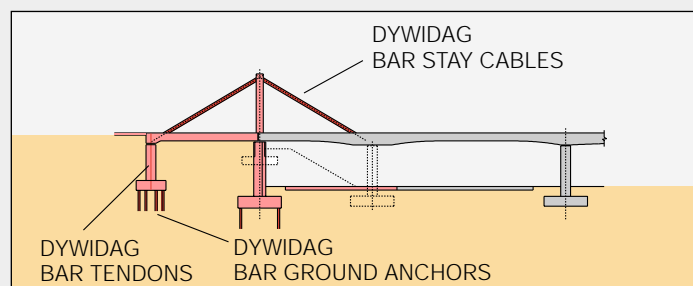
Vertical prestressing of the deadman pier shafts was executed with ø 36 mm DYWIDAG bar tendons (THREADBAR®) placed within a void to allow for longitudinal movements. To anchor the footings of the deadman piers against uplift forces of the stay cables ø 36 mm DCP DYWIDAG ground anchors were used. The stay cables consisted of eight ø 36 mm DYWIDAG bars (THREADBAR®) inside individual steel pipes, which were cement grouted after stressing.

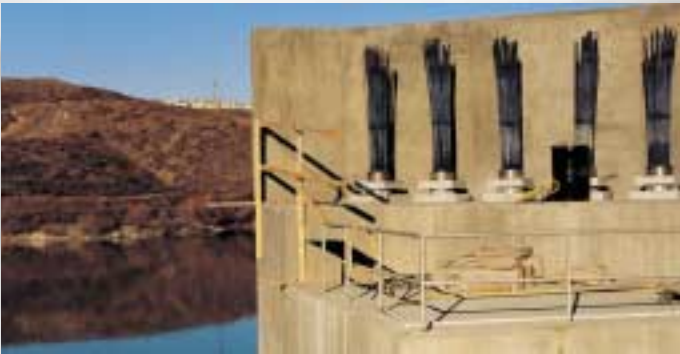
Railroad Canyon Dam, Canyon Lake, California, USA

The existing dam consisted of a thin 32 m high concrete arch section supported by concrete thrust blocks and concrete gravity wing walls. Earthquake specialists found that during Maximum Credible Earthquake water would probably overtop parapet walls, resulting in dam failure. For this reason each of the thrust blocks and wing walls were raised by adding new concrete. To increase stability, new and existing concrete was connected with anchors. The final design included six 27x0.6" and nine 48x0.6" DYWIDAG rock anchors with lengths up to 48 m. Flo-Fill/Flo-Bond epoxy coated strand was used for corrosion protection reasons. To allow for future load adjustment and long-term monitoring, special wedge plates with external thread and load cells were used.
