**Repair & Strengthening****Reference Details:**

**50-70 m long DYWIDAG Multistrand Anchors tie down Gilboa Dam****Stabilization of the Gilboa Dam, Schoharie, NY, USA**

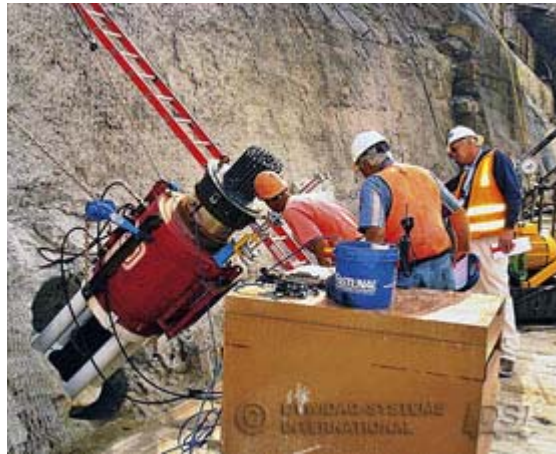
DSI Scope Supply of 83
DYWIDAG Double Corrosion
Protected Multistrand Anchors
with 39 to 58 strands between
50 m to 70 m long; rental of
stressing systems and
accessories

DSI USA supplied a total of 83 Double Corrosion Protected Anchors with 39 to 58 strands which were between 50 m and 70 m long. The challenging prestressing operations were successfully carried out using a 15,000 kN stressing jack that was specially developed by DSI.
