**Owner** New Jersey Highway Authority, NJ, USA +++ **General Contractor** Conti Enterprises, South Plainfield, NJ, USA

**DYWIDAG Post-Tensioning System Stabilizes Important Highway Bridge**

**Reinforcement of Driscoll Bridge over Raritan River, Keasbey, NJ, USA**

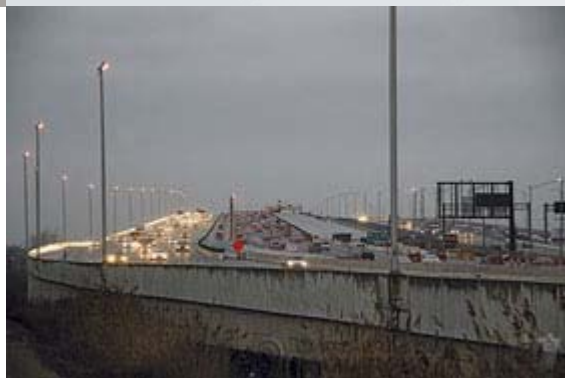
DYWIDAG Multistrand Tendons, which were newly installed, now ensure the necessary strengthening for absorbing additional moment loads. The design includes two custom DYWIDAG anchorages, bolted to the existing structure, and a center deviator, to give the post-tensioning strand the eccentricity necessary to create the additional moment capacity. The DYWIDAG Post-Tensioning System, which was used because of its high quality and reliability, was applied to each of the 201 floor beams comprising the 29 spans of the bridge. All in all, DSI installed 201 DYWIDAG Multistrand Tendons with nominal diameters of 0.6", 270ksi, with 3 to 5 strands each.
