■ Slope Stabilization

**Use of DYWI® Drill Hollow Bars to upgrade centennial bridge foundation**

**Fairchild Creek Viaduct, Brantford, Ontario, Canada**

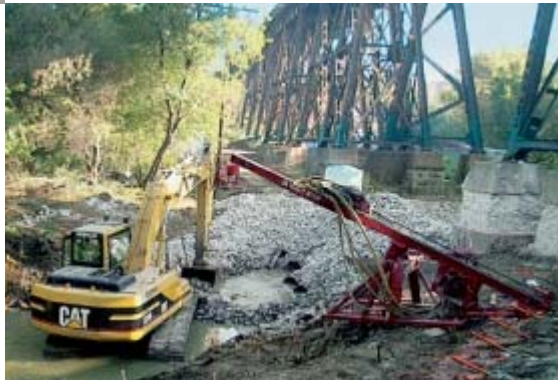
Drilled micropiles formed a portion of the new reinforced concrete ring beam 's foundation, while multiple raked soil anchors were drilled 20 m deep into the slope to provide lateral resistance from strata beyond known slip-surface limits. Soil nailing of the south bank consisted of four rows of 15 m long nails on 1 m lateral spacing to treat over 220 m<sup>2</sup> of slope face. A coated multi-strand polyester geogrid was installed in tension over the ground surface and anchored to the soil nail heads before being treated with topsoil and hydro seeding.

Soil nails consisted of DYWI® Drill Hollow Bars type R32N, a fully threaded steel bar that can be drilled and grouted into loose or collapsing ground without drill casing. The drilling inclination for the project varied from 15° to 35°. Corrosion protection for soil nail components was provided by metallization, the first such application for soil nails in Ontario, Canada.
